# A review of impact testing on marine composite materials: Part III - Damage tolerance and durability

**Abstract:** Composite materials are now used throughout the marine industry but their susceptibility to impact events is still an unresolved problem. The complex nature of the problem in terms of the distinct material and impact event parameters specific to marine applications has been discussed in parts I & II. Tolerance to impact damage is very often of greater concern than resistance to a catastrophic failure and hence the compression, flexural and other loading tolerance of marine composites to impact is reviewed here. Since in-service impacts will occur in the aggressive marine environment, studies on water absorption, temperature and repeated impact effects have also been discussed. Together with parts II and III, this paper gives a comprehensive review of 'marine impact on marine composites', providing a valuable resource for the marine industry and research fields.

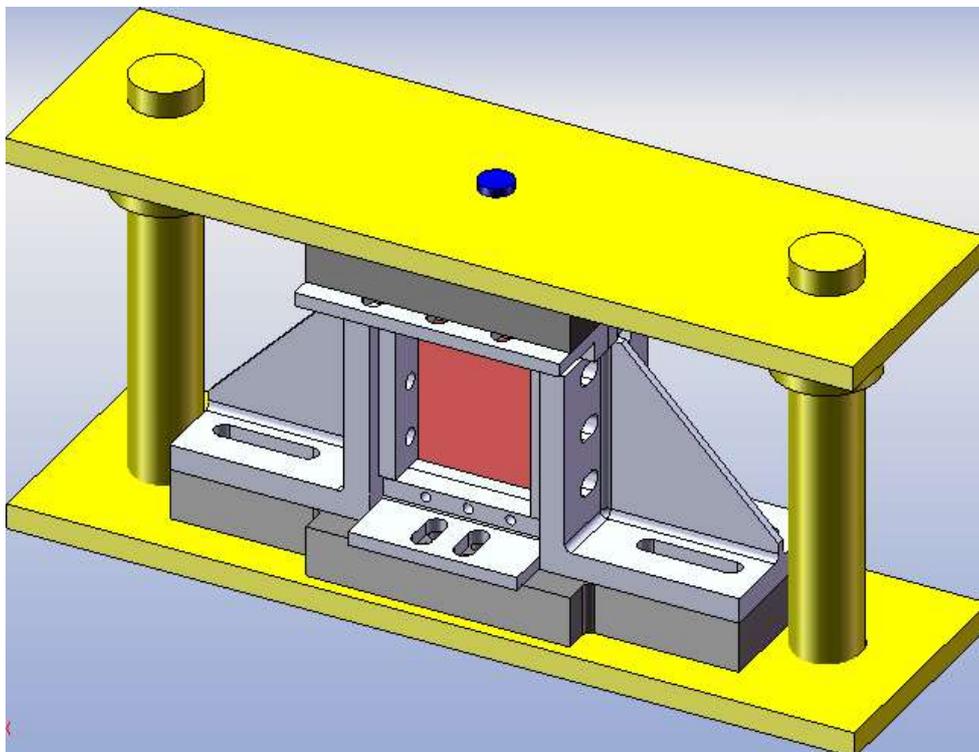
1. Inspection: specimen fabrication defects (and later, impact damage) are assessed with non-destructive evaluation (NDE) techniques.
2. Impact: the specimen is subjected to a controlled impact event.
3. Compression: the damaged specimen is subjected to in-plane quasi-static compression in a CAI support to prevent global buckling (Fig. 1).

Figure 1: CAI Support (composite laminate in red)

The loaded edges must be exactly parallel to achieve a symmetric loading and avoid failure at the upper and lower edges where load is applied, and for thin laminates tabs to increase the loading area may also be required [7].
